# WSAFCA CHP Project

## Status Report, 9/25 - 10/08/2011

This report summarizes the levee construction activities on the CHP Academy Project from the 25th of September through the week ending the 8th of October.

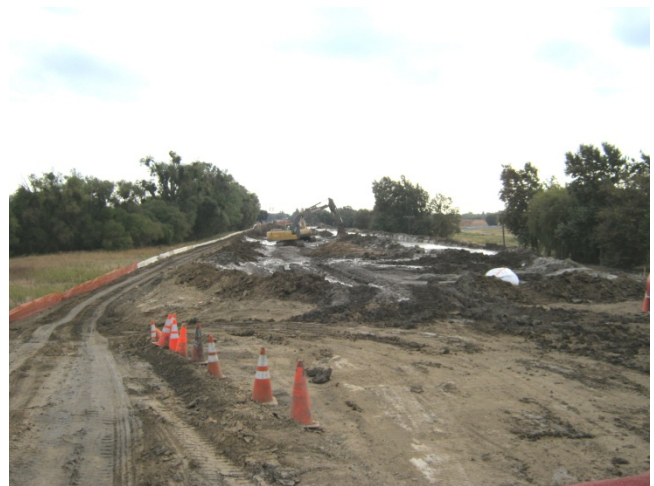
The slurry wall has been completed including final backfill top out as of October 1st. The contractor completed installation of the settlement monitoring plates on October 1<sup>st</sup> as well. Currently, there are four monitoring plates still being checked, each five hundred feet apart with the last one located at Station 21+00.

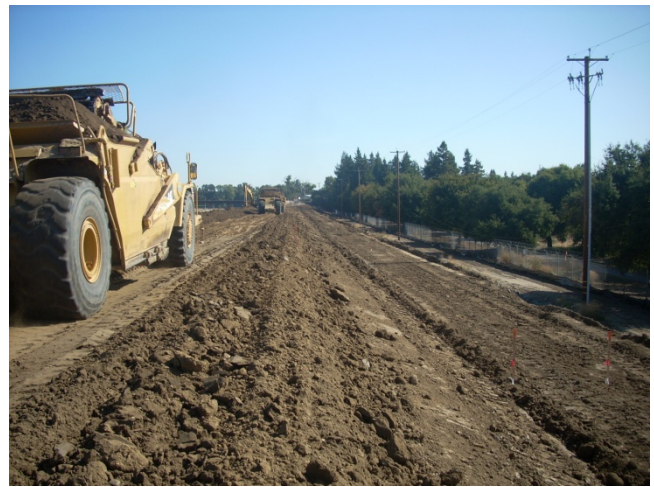
On the 29th of September Teichert began the reconstruction of the levee and continued the degrade of the existing levee. Work began by excavating the waterside slope of the existing levee for the first 2000+ feet from the easterly limits and cutting in the key trench for the concrete slope protection footing. While this work was proceeding, embankment was also placed on top of levee over the same range. Teichert filled and compacted the concrete slope protection footing material. After a few feet of fill had been placed on either side of the slurry wall the temporary cap was removed and replaced with the permanent cap. Upon completion

of the permanent cap for a given area the embankment was continued across the entire width of the levee. As of the 8th of October, the first 2000+ feet of the levee is within only a few feet of finished grade. Teichert has also begun grading the landside slope over this same range and the waterside slope over the remainder of the project. To date, all of the embankment placed has been sourced from the original levee degrade. It is anticipated that the stockpiled material from the degrade will be used up by the 10th of October.
